RIVER HABITAT AND MACROPHYTE SURVEYS IN THE HIGH TATRA MOUNTAINS OF SLOVAKIA AND POLAND

Results from 2010

A report by Paul Raven¹, Nigel Holmes², Hugh Dawson³, Agnieszka Ławniczak⁴,
Eva Bulánková⁵, Jan Topercer⁶ and Iga Lewin⁷.

March 2011

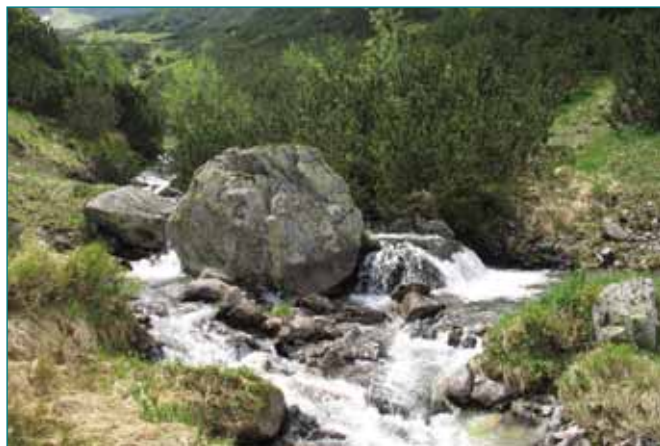
Principal Components Analysis allows comparison of similar river sites, based on map data.

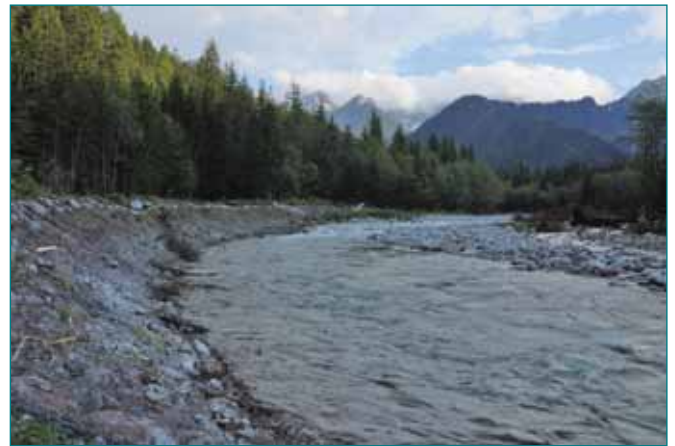
Re-profiled bank with wire basket gabions.

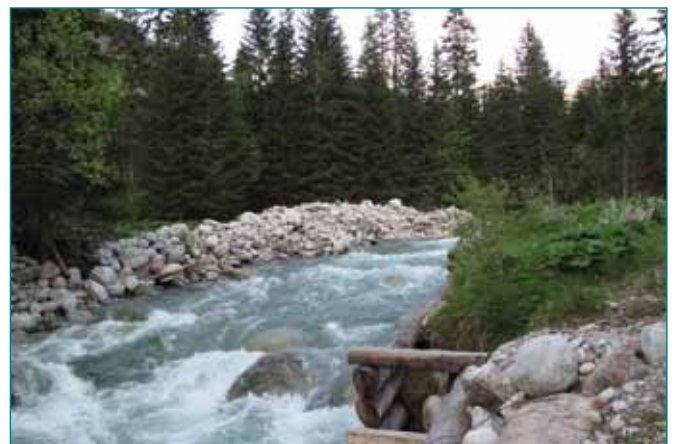
Boulders removed from the stream-bed.

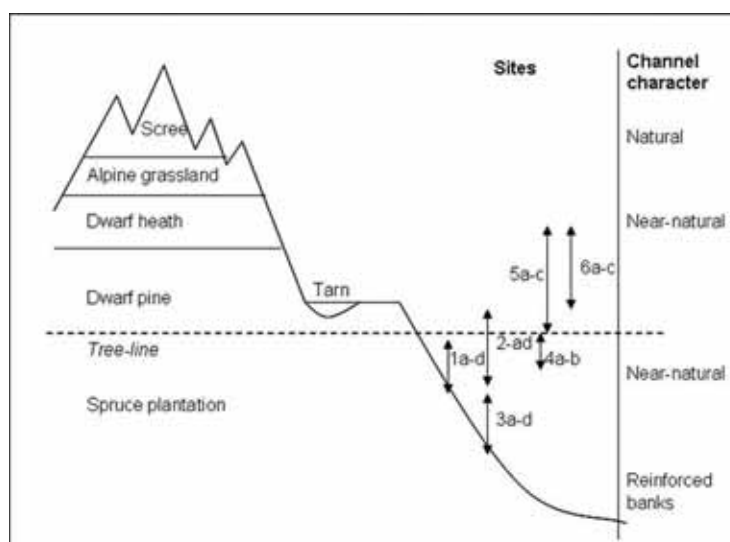
Figure 1. Schematic cross-section of the High Tatras, showing the position of our survey sites.

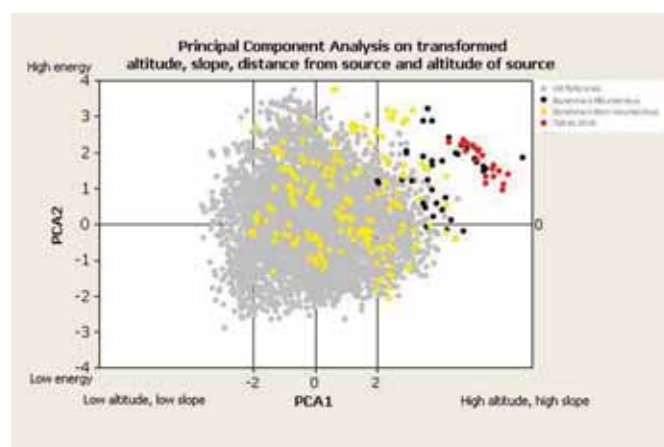
Figure 2. PCA plot, showing the Tatra sites (red) compared with high altitude (black), other benchmark sites (yellow) and the UK baseline survey sites (grey).

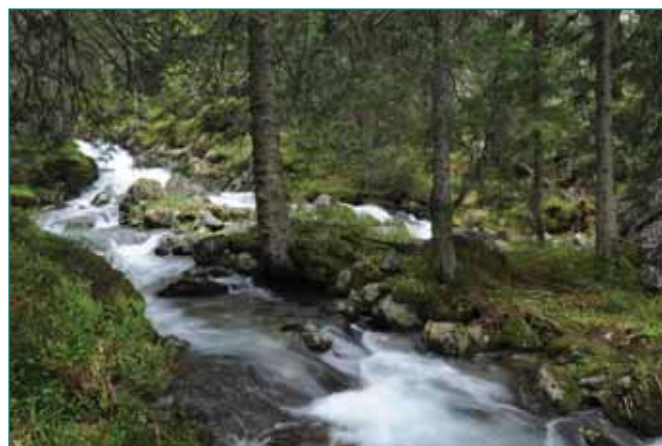
Mature island, Biela voda.

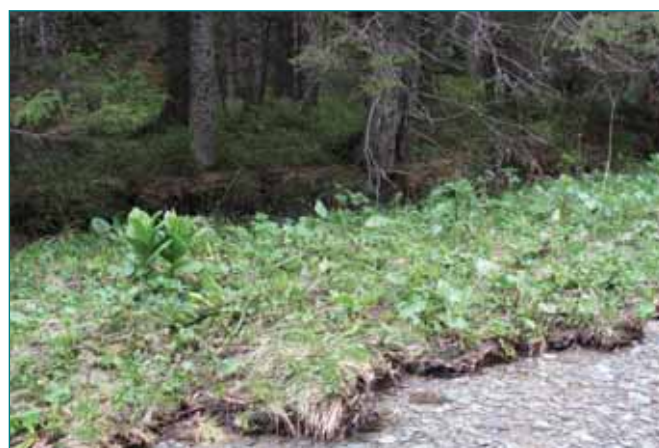
Natural berm/terrace formation, Biela voda.

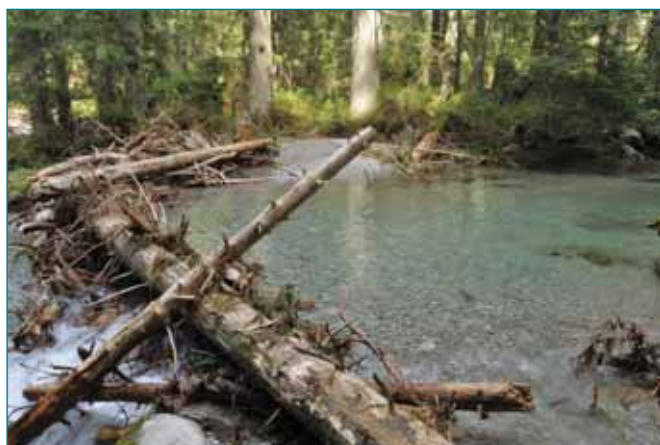
Spruce trunk debris dam, Javorinka.

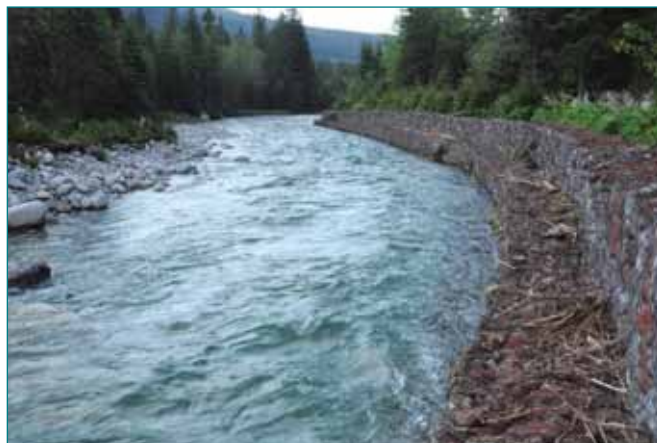
Bank reinforcement on the Biela voda downstream of our survey sites.

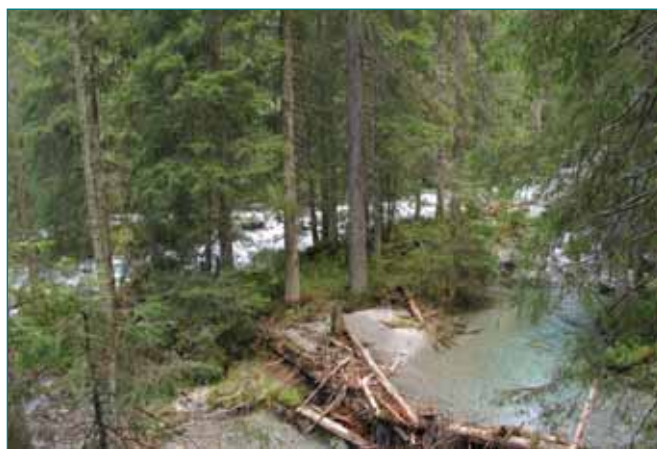
Local impoundment caused by a debris dam, Tatra 1c.

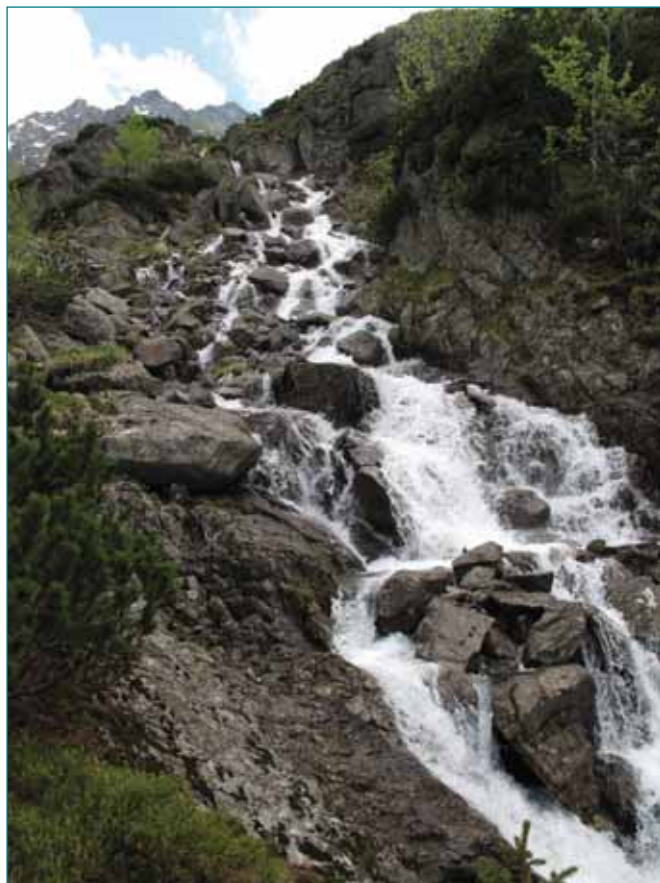
A bedrock chute, Litvorový potok, Tatra 2a.

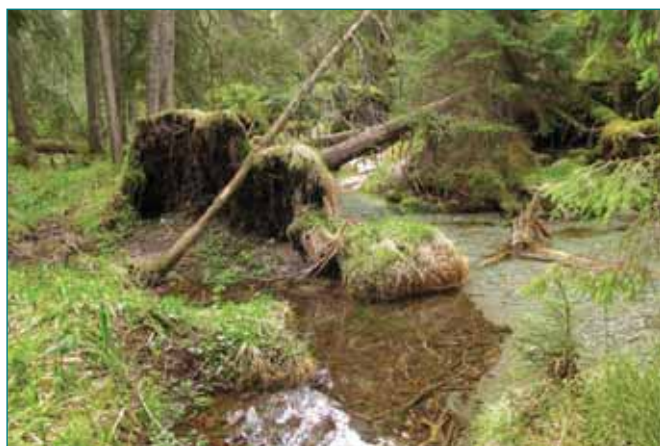
Back channel habitat, Tatra 2d.

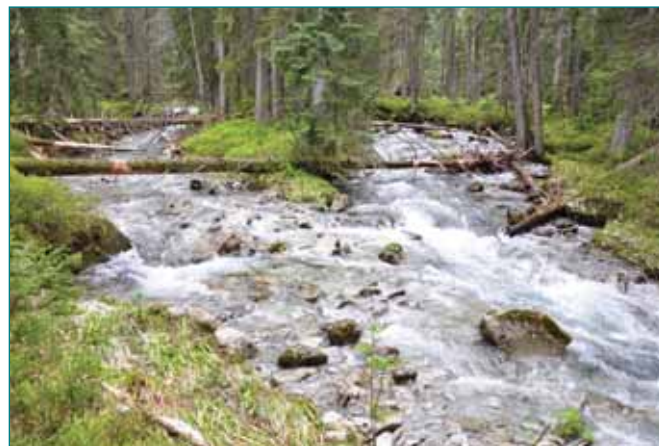
Mid-channel island, Tatra 2c.

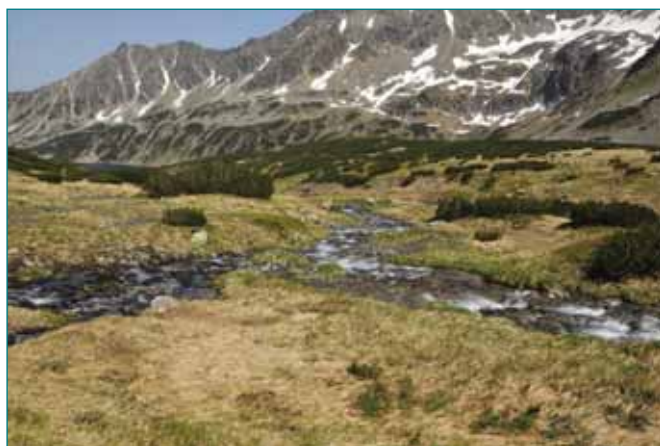
Stepped channel profile and moraine terraces, Tatra 6b.

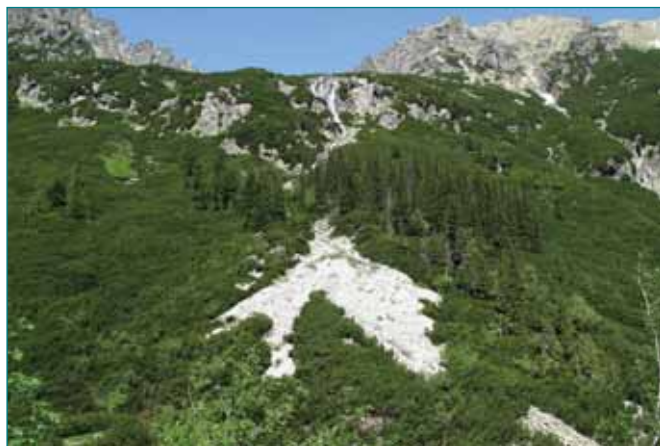
Avalanche track colonised by dwarf pine.

Avalanche tracks: *it is recommended* that these are recorded as a special feature in section M on the RHS form, as well as 'scree' land-use in Section H. This is because they provide morphological evidence of natural instability. In the spruce plantation forests of the High Tatras they represent important sources of natural regeneration because they are colonised by native species such as bilberry, broadleaf shrubs and, at higher altitudes, dwarf pine. Indicating whether the tracks are predominantly vegetated or unvegetated is also recommended.

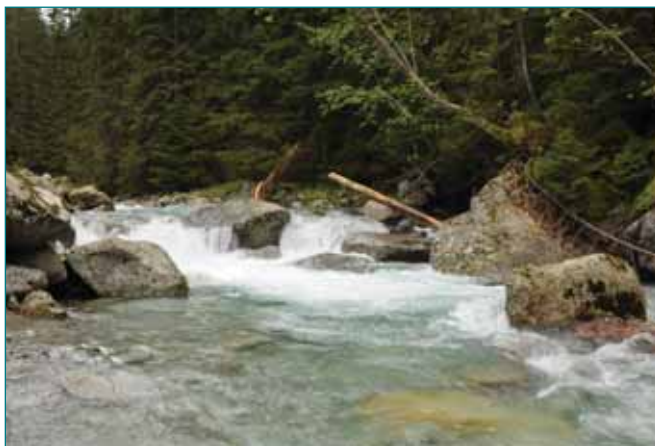
Chaotic flow is a feature of boulder-bed torrents.

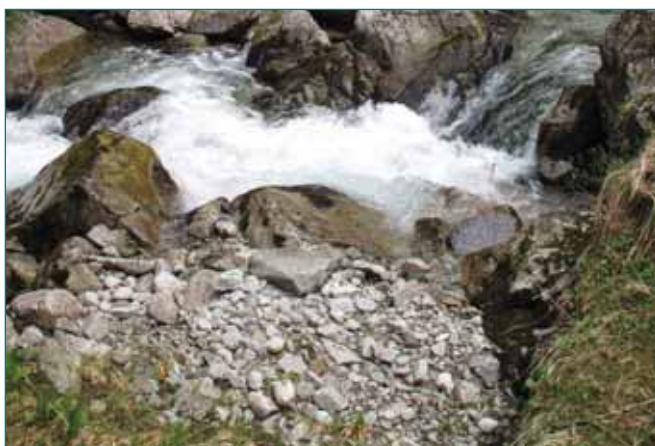
Discrete deposit in a small stream.

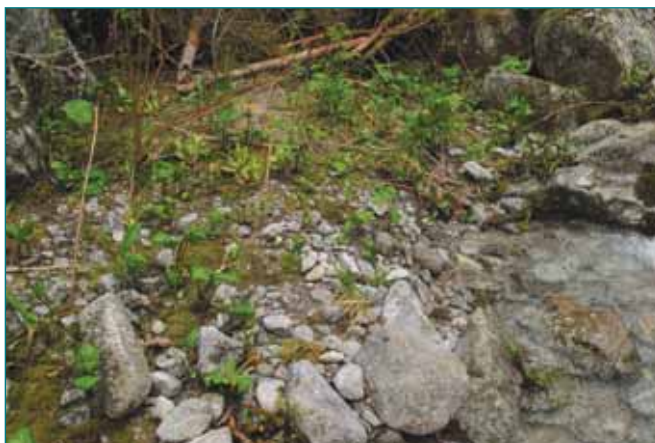
A vegetated discrete deposit.

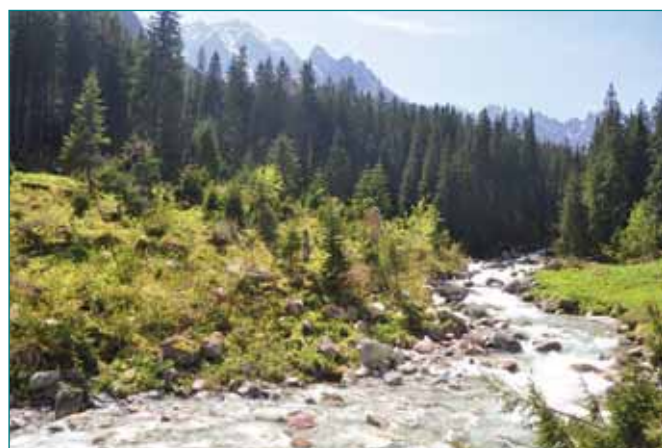
Re-naturalising plantation forest. See Table 6.

Forest structure and character	Proposed HQA score	
	Present	Extensive
Closed; even-aged. Dense trees, little light, no understorey.	0	0
Closed; even-aged. Thinned trees, sparse understorey.	0	0
Open; even-aged. <i>Vaccinium</i> understorey.	0	1
Open; even-aged. <i>Vaccinium</i> understorey, decaying fallen trees.	1	1
Open; multi-aged, patchy. <i>Vaccinium</i> understorey, fallen trunks, broadleaf trees present.	1	2
[Areas of unmanaged windthrow/bark beetle damage, patchy. Dead wood, broadleaf trees, tall herbs].	1	2
[Areas of avalanche/scree. Open. Dwarf pine and broadleaf species].	1	2
